SAS Superstructure

Daily Diary Report by Bid Item

Diary #: 518 Const Calendar Day: 296 Date: 27-Mar-2013 Wednesday

04-0120F4
04-SF-80-13.2/13.9
Self-Anchored
Suspension Bridge

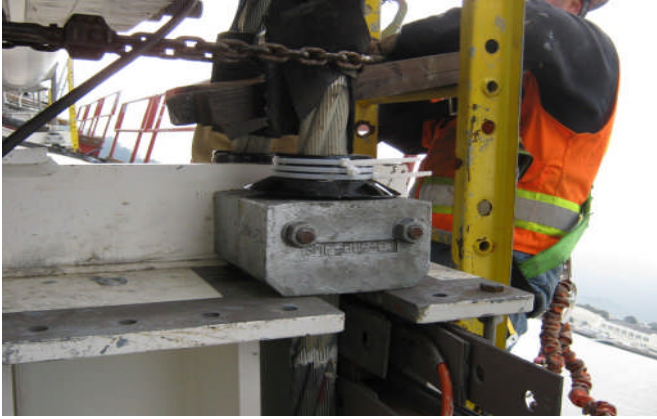
Final installed elastomeric collar at PP 110N

- A new elastomeric collar was prepped for installation. The faces between the 2 halves were primed with acid prior to placing the adhesive.
- The back half of the elastomeric collar was installed.

- Adhesive was applied to the faces between halves of the elastomeric collar.
- The front half of the elastomeric collar was installed. - Note: zip ties were installed around the top of the elastomeric collar to hold them together while the adhesive sets.

- The front half of the split collar was installed.
- New nuts were installed on the rod, & the nuts were tightened slightly. They were only tightened enough to hold the halves of the elastomeric collar tighter without squeezing too hard to possibly interrupt the adhesive between the halves.

- Blocking was placed in the areas of the jacks to maintain the position of the suspender rope while the adhesive cures.
- At 17:00, I left the bridge.
- From 17:10 until 17:45, I spoke with Warren Collins regarding the elastomeric collar removal & installation today. I brought the old elastomeric collar from PP 110N to show him the area of the collar that split under the compression of the suspender rope pressing hard against it.

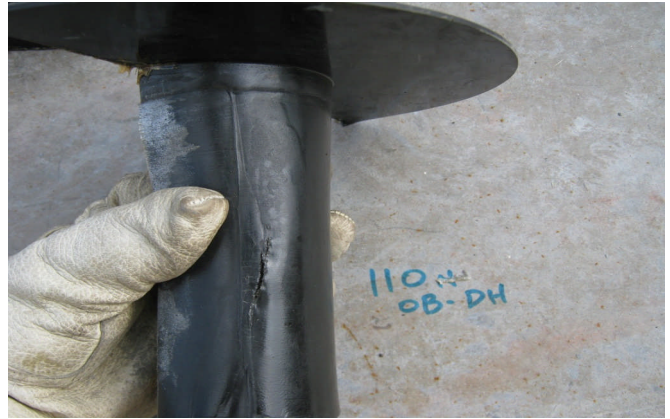
- The elastomeric collar was removed. I inspected it, & found a split in one half of it. This was in the area where the collar is compressed because the position of the suspender rope squeezed hardest against it in this area. See attached photo.

Split in the old elastomeric collar at PP 110N

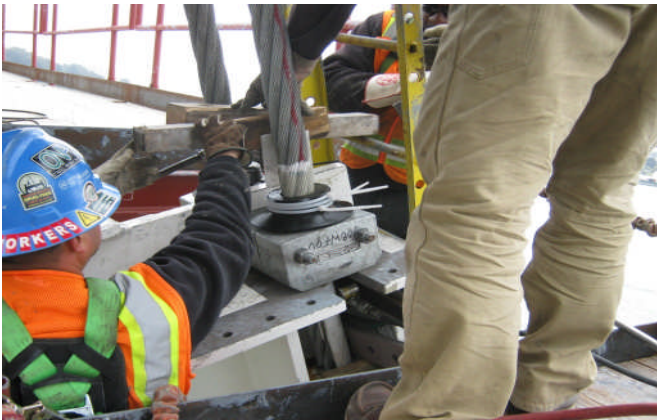
- The elastomeric collar was removed. I inspected it, & both halves were in good condition.
- A new elastomeric collar was prepped for installation. The faces between the 2 halves were primed with acid prior to placing the adhesive.

Final installed elastomeric collar at PP 108N

- The back half of the elastomeric collar was installed.
- Adhesive was applied to the faces between halves of the elastomeric collar.
- The front half of the elastomeric collar was installed. - Note: zip ties were installed around the top of the elastomeric collar to hold them together while the adhesive sets.

- The front half of the split collar was installed.
- New nuts were installed on the rod, & the nuts were tightened slightly. They were only tightened enough to hold the halves of the elastomeric collar tighter without squeezing too hard to possibly interrupt the adhesive between the halves.

- Blocking was placed in the areas of the jacks to maintain the position of the suspender rope while the adhesive cures.

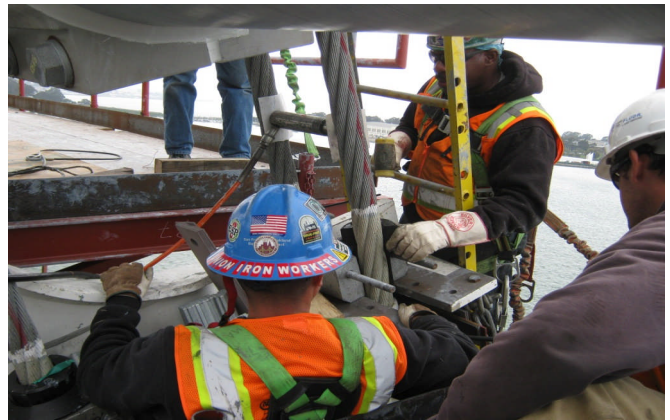
- The position of the suspender rope was shifted with the use of small jacks to get clearance for removing the elastomeric collar. - Note: Softeners were used between the jacks & the suspender rope. See attached photo.

Jacking on suspender rope to make clearance for elastomeric collar removal & re-installation at PP 108N
